Ditch-relief Culverts and Low-volume Forest Roads in the Oregon Coast Range²

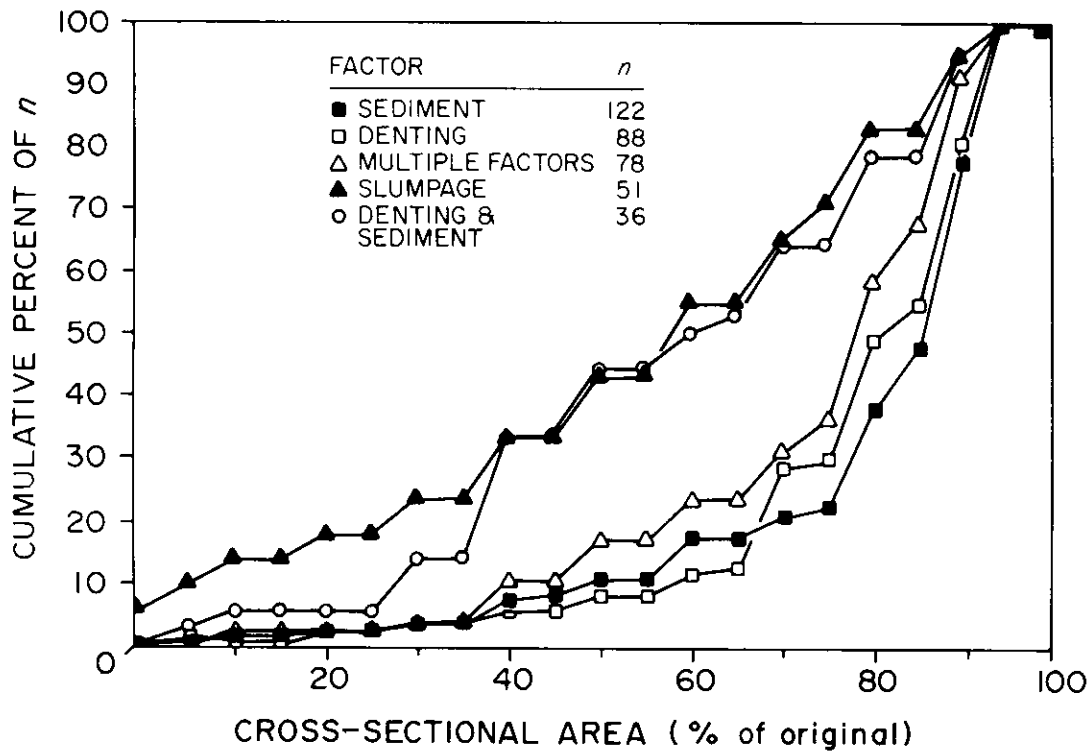
The relative importance of sediment plugging, pipe damage, cutbank sloughing, organic debris blockage, or combinations of these factors was evaluated by expressing existing cross-sectional area of the culvert inlet as a percent of original area (Figure 3). Average cross-sectional area for all DRC inlets was 81 percent of original; averages ranged from 73 percent for private lands to 85 percent for state lands.

Inlet areas had been reduced in 74 percent of the DRC's. Sediment deposition, occurring at 24 percent of the installations, was the main cause. Physical damage or denting, the second most frequent cause, occurred at 17 percent of the installations. Where sediment deposition or denting occurred separately, each reduced the cross-sectional area of DRC inlets to an average of approximately 80 percent of original area. Another 7 percent of the culverts were reduced by combined effects of sediment and denting; average cross-sectional area for these pipes was only 61 percent of the original. Thus, inlets of nearly half (48%) of the DRC's were reduced by sediment, denting, or both. Cutbank slumpage severe enough to affect entrance conditions was

Figure 3. Factors affecting reduction in cross-sectional area of ditch-relief-culvert inlets.

relatively infrequent (10% of all DRC's) but reduced inlet cross-sectional area to an average of 56 percent of the original. Only 1 percent of the DRC's were plugged by organic debris. Multiple factors affected inlet cross-sectional area in another 15 percent; area of these inlets averaged 74 percent of original area.

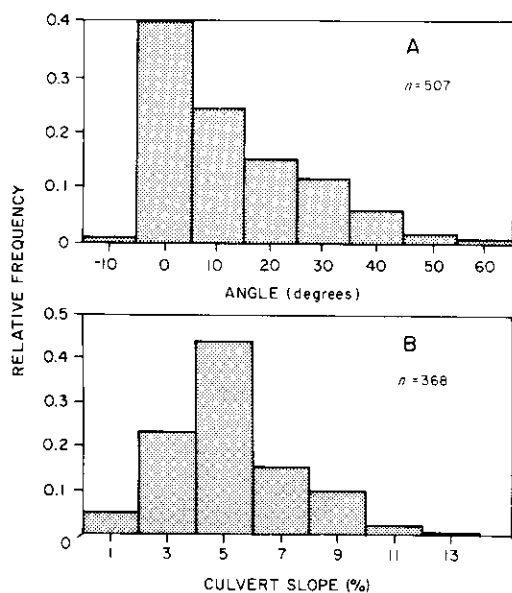
(Figure 1); skew angles in this study averaged 15° (Figure 4A). Greater skew angles should help pass water, sediment and debris through culvert inlets. As skew angle decreases, water flowing along the ditch and any transported material must turn more sharply to enter the pipe; as a result, water velocity is reduced and sediment, organic debris, or both may be deposited. However, reductions in cross-section area at DRC inlets by sediment and debris accumulation were not significantly correlated with skew angle ($P > 0.10$).

The slope of DRC's generally should be at least 3 percent to maintain high water velocity and prevent deposition of sediment (Rothwell 1978); over 90 percent of the DRC's met this criterion. Culverts also should be inclined 2 percent more than the road grade (Rothwell 1978); only 40 percent of the DRC's in this study satisfied this criterion. Average slope of DRC's was 6 percent (Figure 4B); average road slope was 7 percent. Sediment deposition at DRC inlets was less at

Figure 4. Distribution of (A) skew angles, and (B) slopes for ditch-relief culverts.

steeper pipe slopes. Unexpectedly, these steeper pipes also had a higher percentage of dented inlets and an increased occurrence of cutbank slumpage.

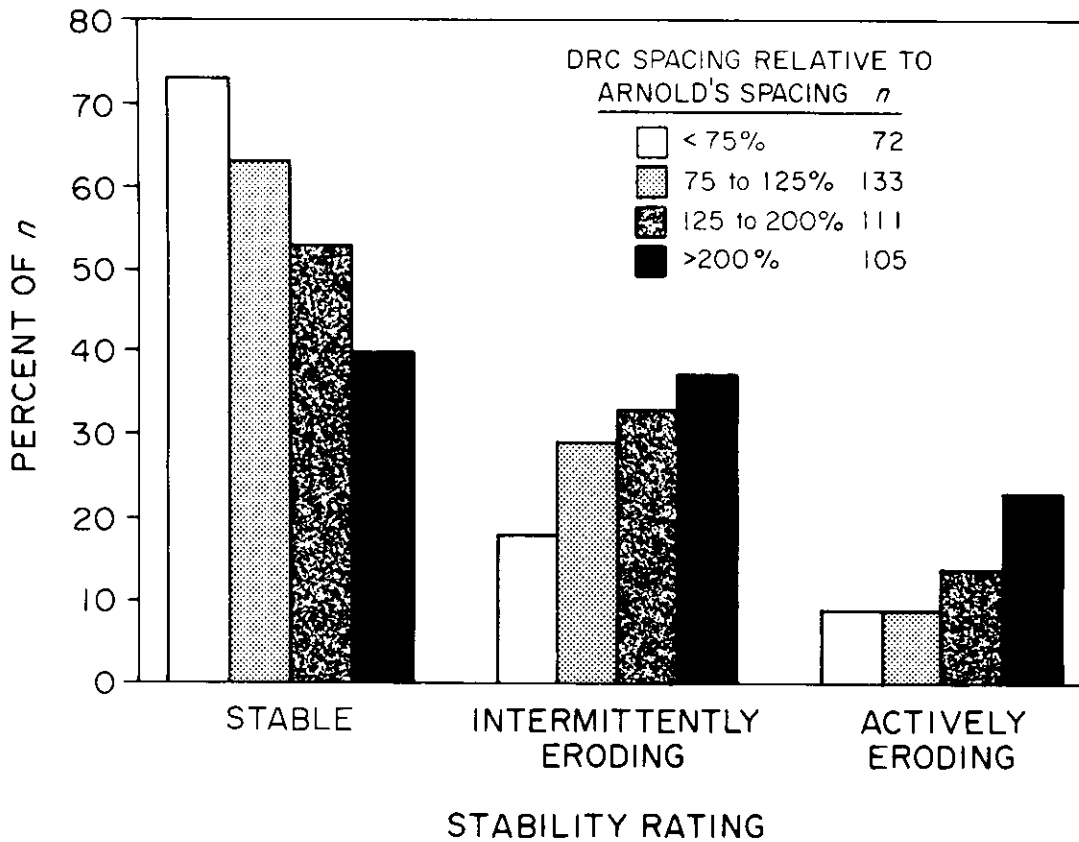
Fillslopes were rated qualitatively and placed into one of three categories: "stable," "eroding intermittently," and "eroding actively." Sixty percent of the fillslopes fell in the first class, 28 percent in the second, and 12 percent in the third. The proportion of culverts associated with intermittently and actively eroding roadfills increased as spacing, expressed as a percentage of Arnold's (1957) guidelines, increased (Figure 5).

Figure 5. Stability rating of fill slopes of ditch-relief culverts (DRC), in comparison with Arnold's (1957) spacing guidelines.
